TS-PIC-96502/9605502S
March 1996

AERIAL PHOTOGRAPHIC ANALYSIS SAM WEINER PROPERTY

Summit County, Ohio

EPA Region 5

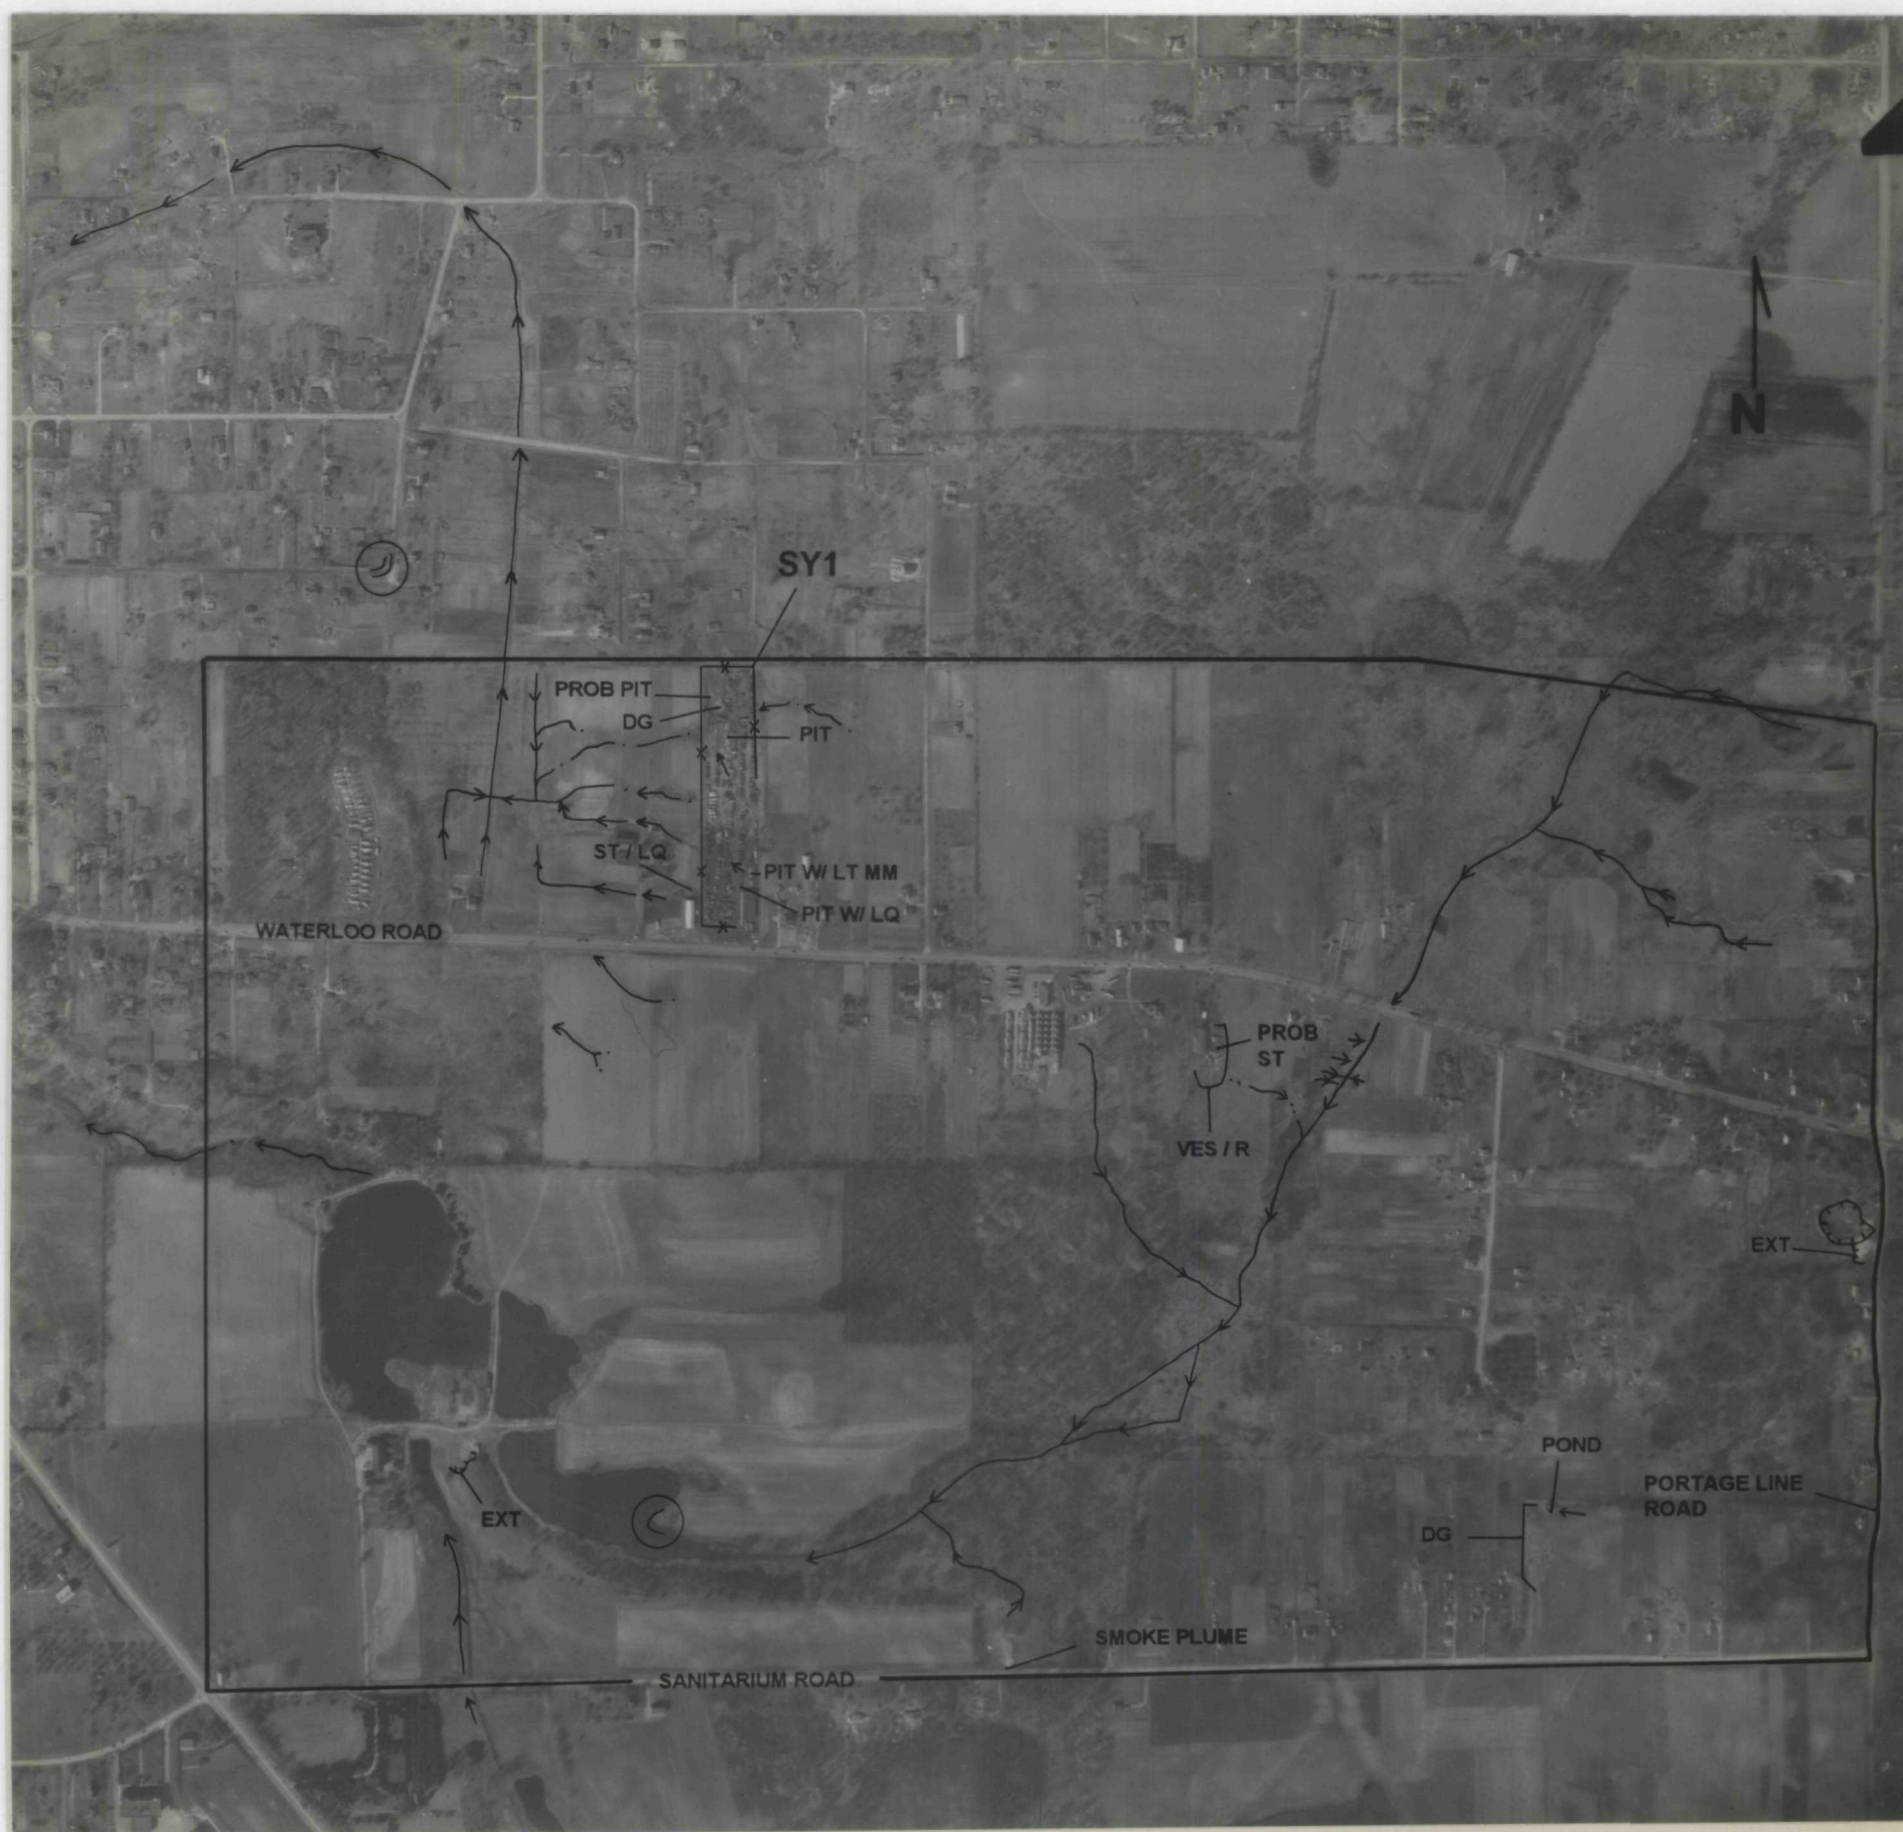
FIGURE 3

Significant findings include a salvage yard (SY1), a vehicle and equipment storage/repair (VES/R) shop, an area of disturbed ground (DG), a smoke plume and two quarry extraction areas (EXT). The northern portion of the east extraction area is inactive.

SY1 is situated on the north side of Waterloo Road and appears to be in the early phases of its operation. The southern portion of the yard is stained (not annotated). A pit containing light-toned (LT) mounded material (MM) and an adjacent pit with liquid (LQ) are present within the southern half of SY1. A ditch extends northwest from the northern pit. A second drainage ditch with a northwest orientation is near the center of the yard. The ditch appears wet and extends to a natural swell leading to westward flowing drainage routes. A probable pit and an area of disturbed ground are noted in the northern end of the yard. Drainage routes pass through the northern end of SY1 and numerous surface water pathways are observed on the west side of the salvage yard. Staining and/or liquid appears to originate from the southwest corner of SY1 and the building west of the site.

Equipment and vehicles are present at the vehicle and equipment storage/repair shop south of Waterloo Road. Probable ground staining (ST) is seen throughout the storage area.

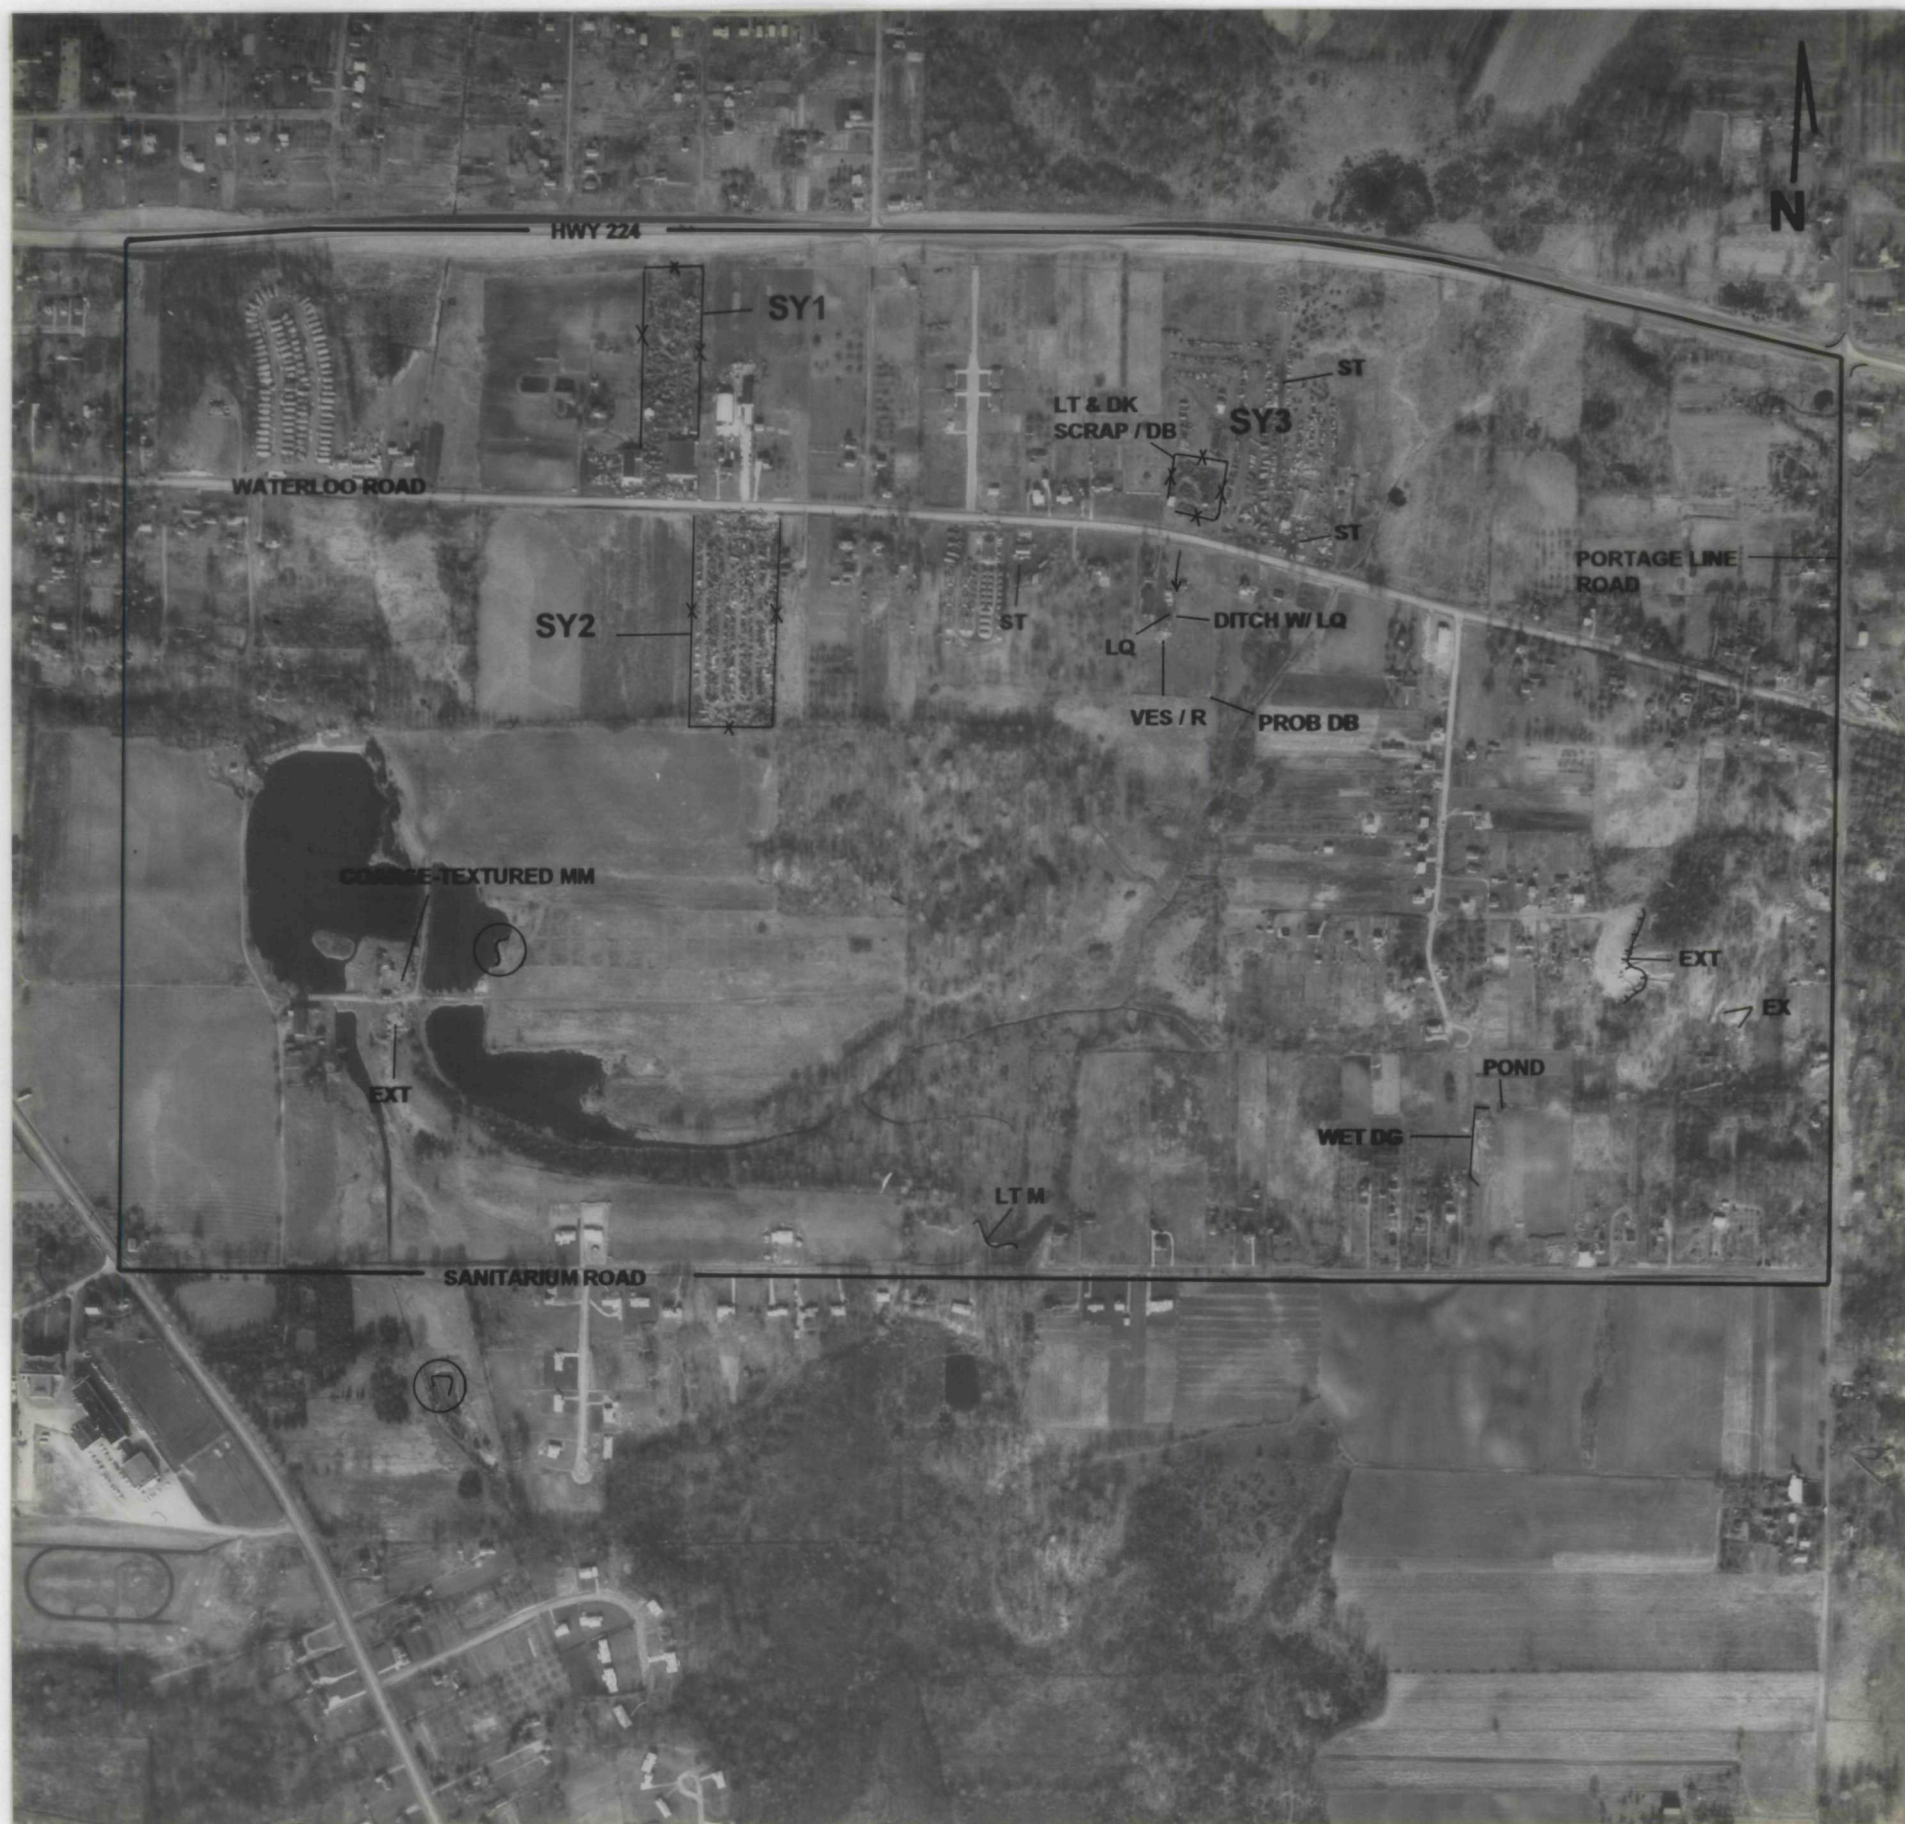
FIGURE 4

Two new salvage yards (SY2 and SY3) are in operation within the study area. A new extraction area is present in the eastern portion of the study area and coarse-textured mounded materials are present north of the extraction area at the lake.

SY1 consists of piles of scrap/debris (DB) on this date. A building has been constructed over the location where the two pits containing light-toned mounded material and liquid were observed in 1952.

SY2 is located southeast of SY1 and consists of numerous junked vehicles.

SY3 is a large unfenced area along the north side of Waterloo Road. Staining is present at the main entrance to the yard and along the road leading into the yard. A stockpile of large items, probably vehicles, is present in the north end of the yard. Vegetated wet areas (not annotated) are present throughout the northern portion of the site. A fenced area with light- and dark-toned (DK) scrap/debris (possibly crushed battery casings) is located in the southwest corner of SY3. The interior road of this fenced area is stained.

A pool of liquid is present on the pavement at the vehicle and equipment storage/repair shop. A ditch containing liquid is present downgradient of the pooled liquid. Probable debris is present southeast of the storage/repair shop building.

Staining/liquid is present between SY2 and the vehicle and equipment storage/repair shop. The specific source of the stain/liquid was not detected.

Light-toned material is present along the upper edge of a gully in the south-central portion of the study area in the vicinity where the smoke plume was seen in 1952.

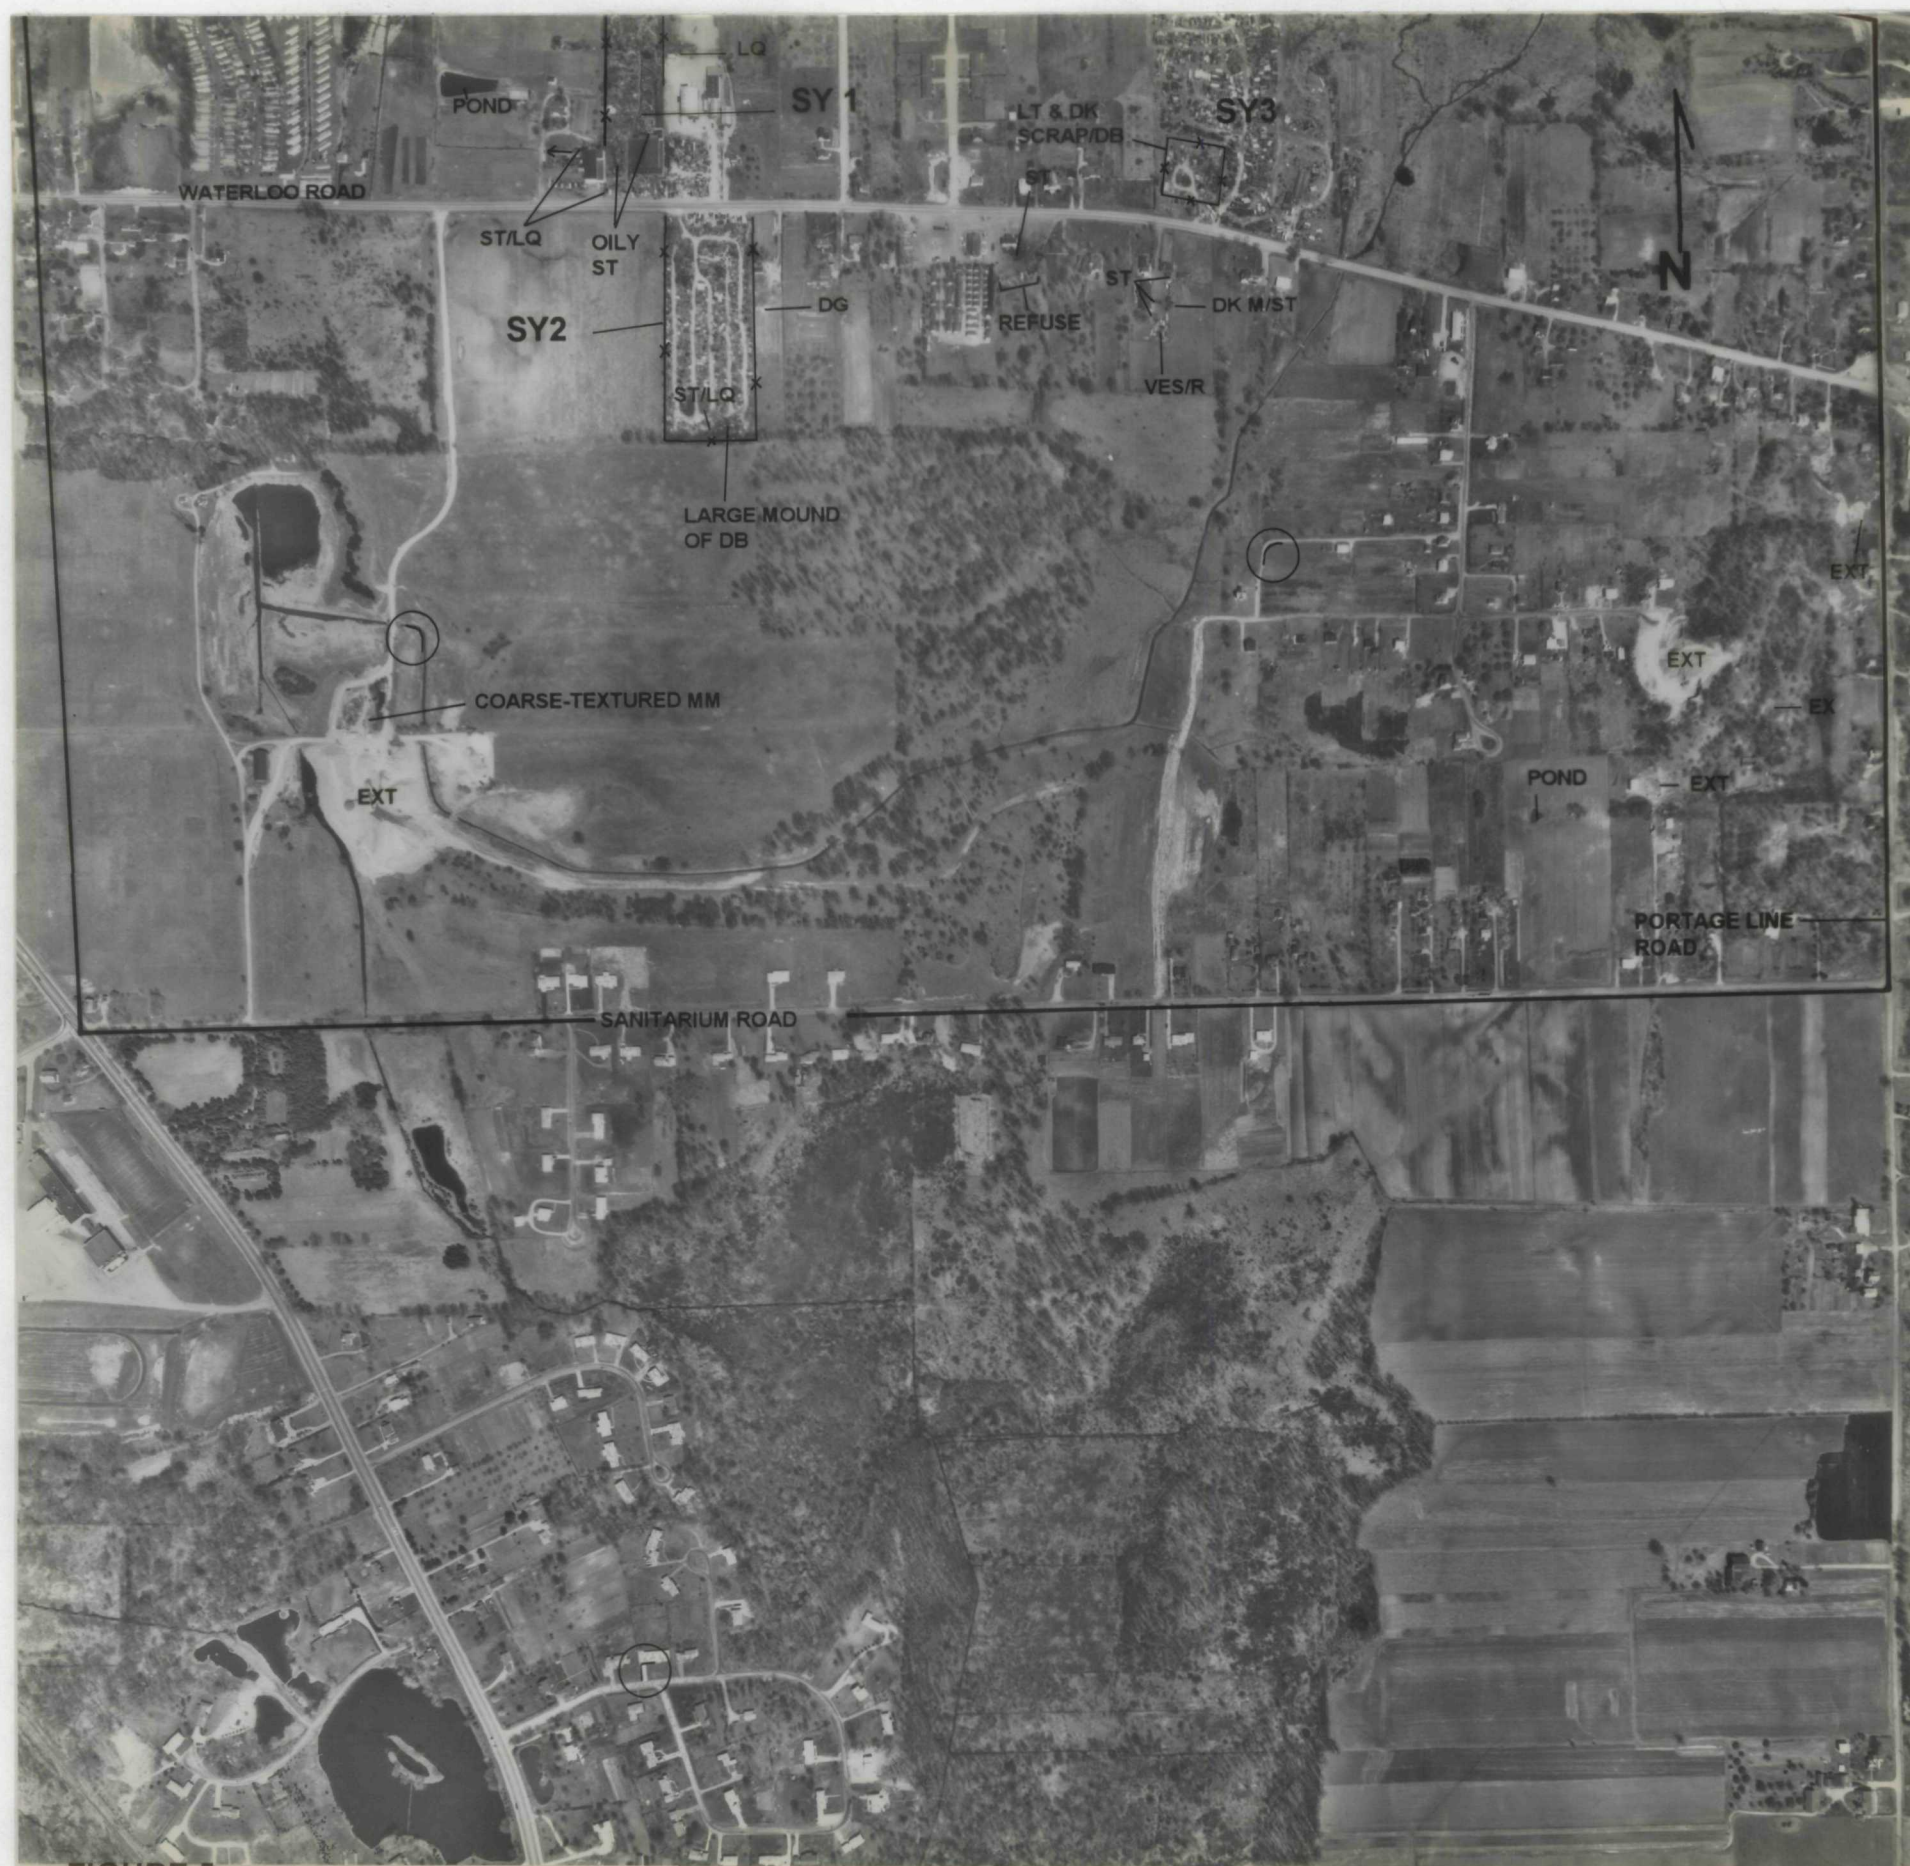
FIGURE 5

The three salvage yards, the vehicle and equipment storage/repair shop and the easternmost quarry remain active. The lake in the west central portion of the study area has been drained and a new extraction area is operating at this location. Other findings include staining and refuse discarded over an embankment between SY2 and the vehicle and equipment storage/repair shop.

Oily stains are present at two locations within SY1; the entrance to the salvage yard and at the north end of the large building within the yard. Stains and liquid flow patterns are present west of the yard. The staining/liquid extends into channelized drainage routes previously annotated. A pool of liquid is present near parked vehicles east of SY1. The specific source for the pool of liquid was not detected.

A large mound of debris is present at the south end of SY2. Staining/liquid, which is partially obscured by the tree canopy and shadowing, extends westward from the pile. An area of disturbed ground is present east of the current SY2 boundary. On future dates of photography this location is occupied by the salvage yard operation.

The amount of salvage material and junked vehicles at SY3 has increased since 1957; however, there is less light- and dark-toned scrap/debris piled within the fenced area of the yard.

Three areas of staining and dark-toned material (M) or staining are present at the vehicle and equipment storage/repair shop. Two of the stains originate from the onsite building and the northernmost stain is adjacent to dark-toned objects (not annotated).

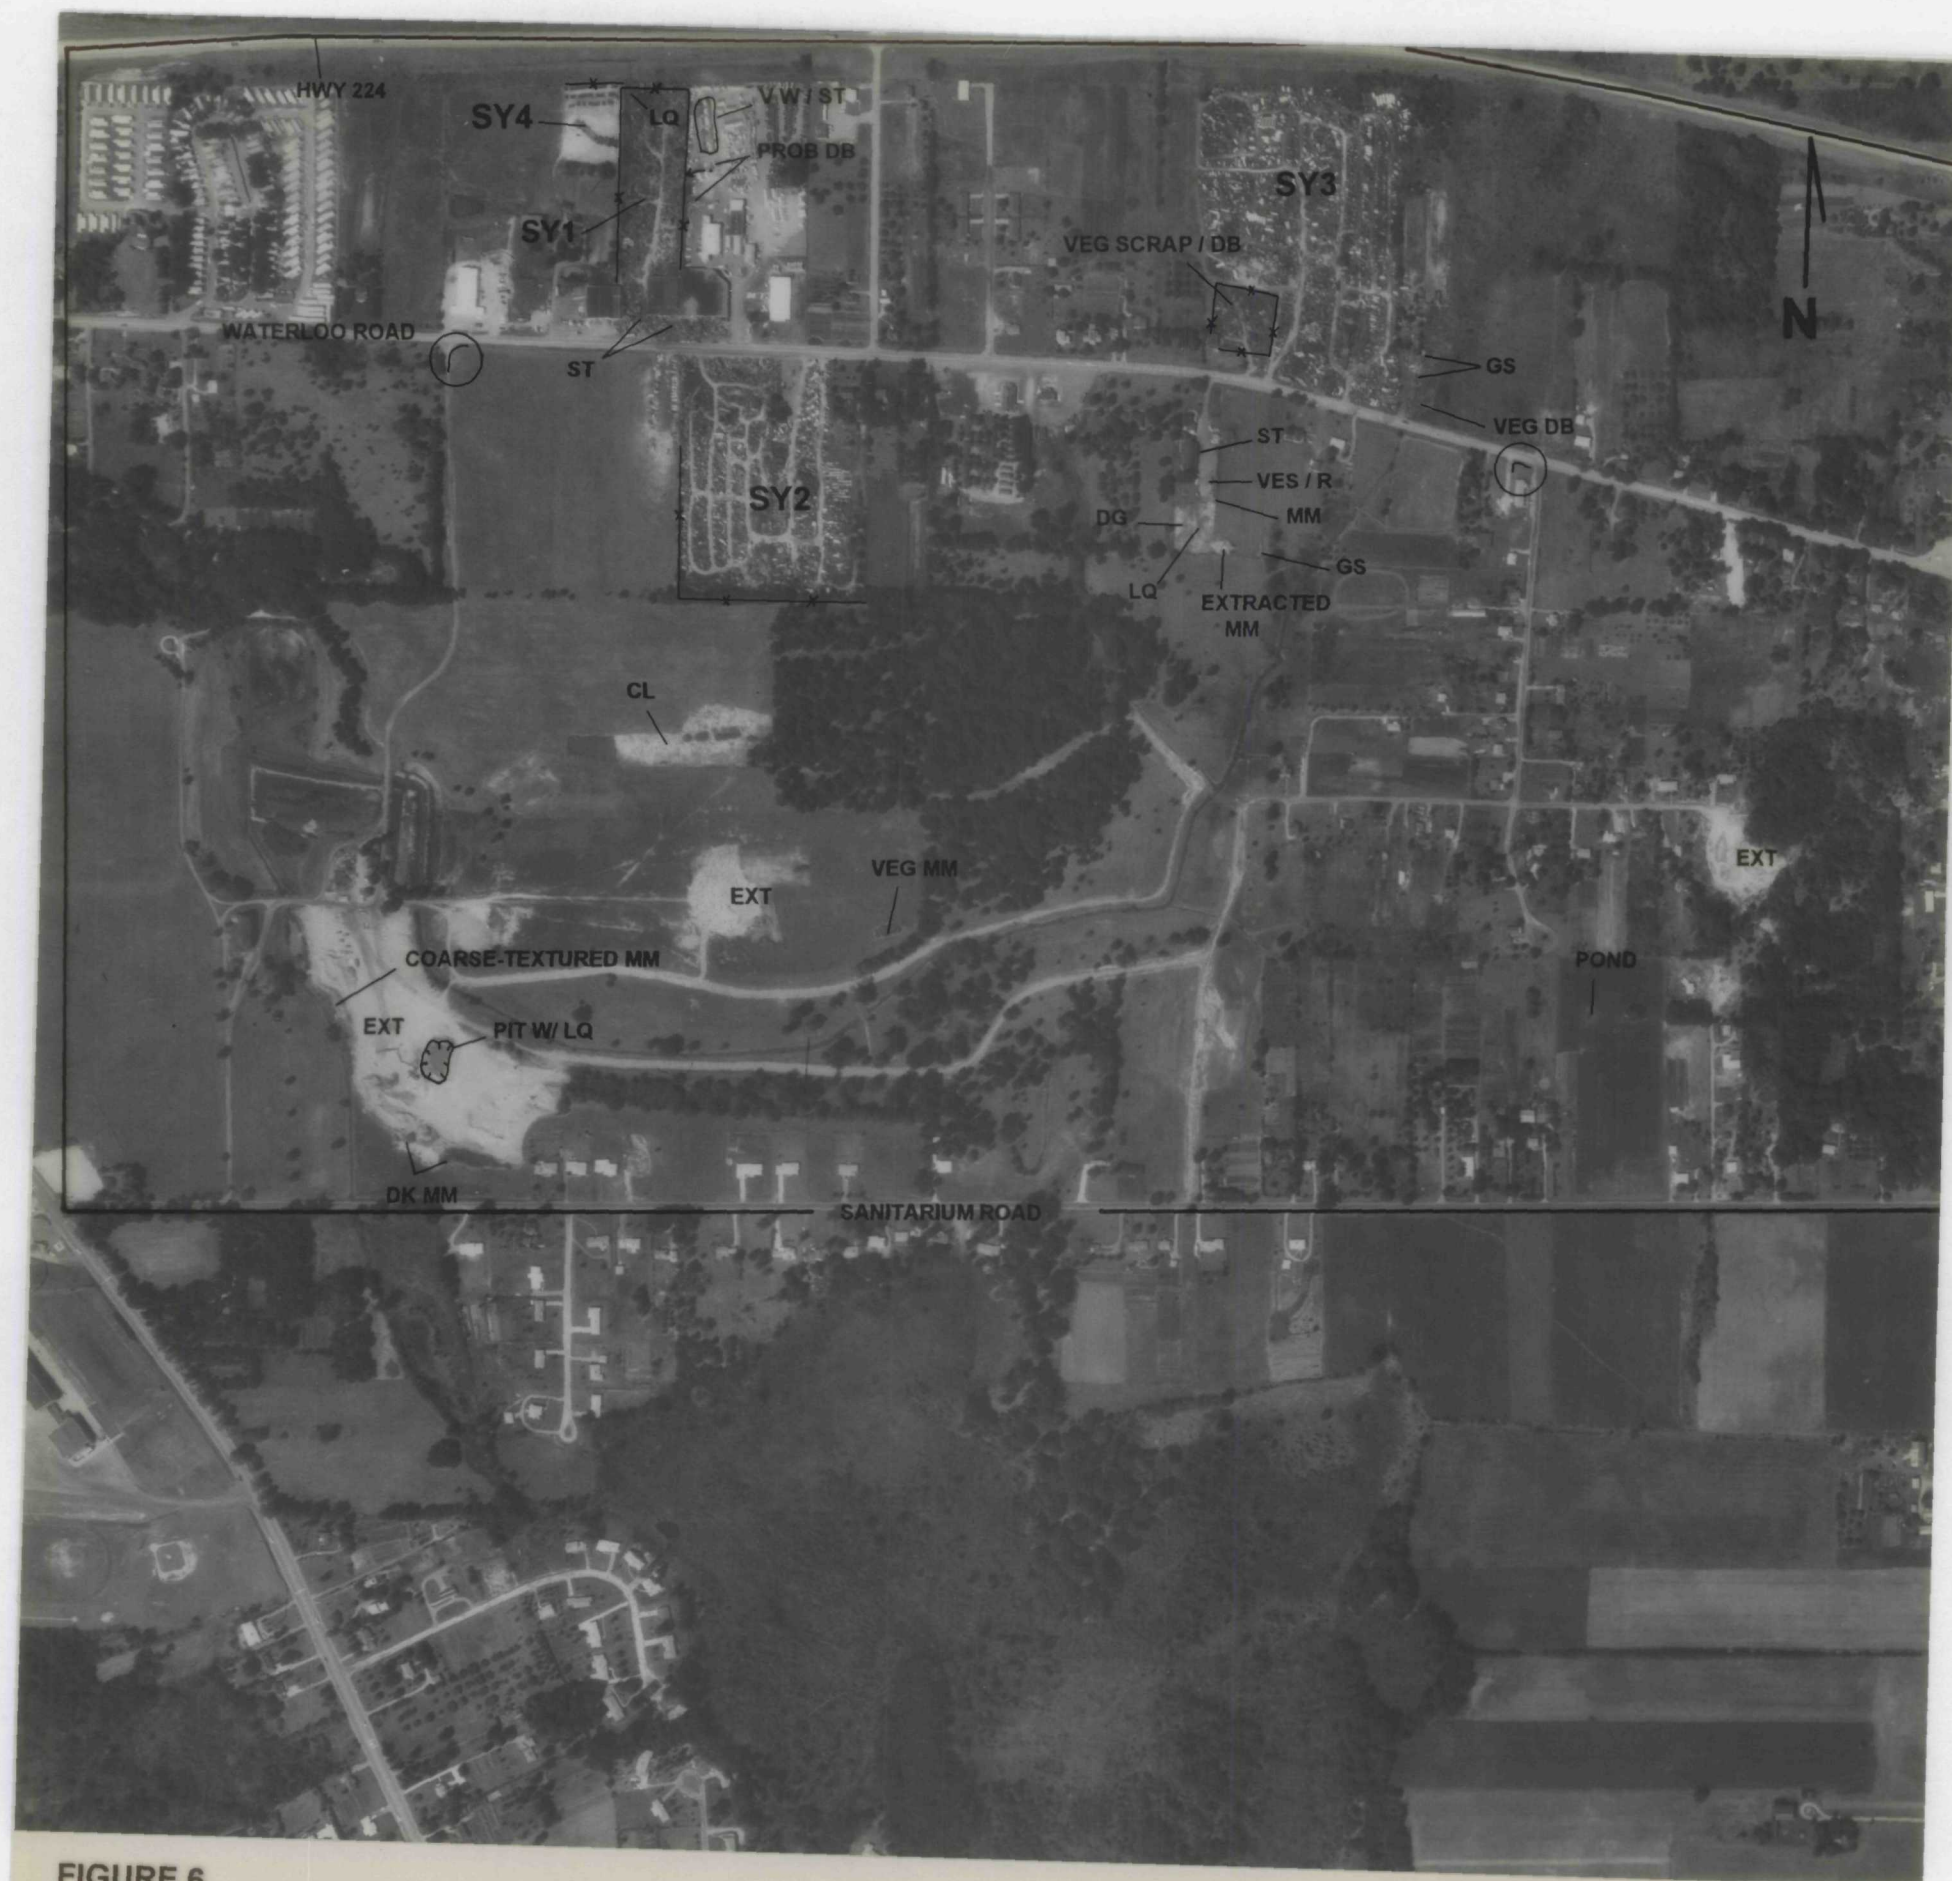
FIGURE 6

The salvage yards, the easternmost extraction area, and the extraction area at the drained lake remain active. An area with vehicles, which eventually becomes a salvage yard (annotated as SY4), is present west of SY1. Extraction activity near the drained lake has increased and a pit with liquid and dark-toned mounded material are present. A new extraction area and a cleared area (CL) are present south of SY2.

Staining is prevalent at the entrance to SY1. Much of the salvage scrap/debris piles are overgrown with vegetation; an indication that there is a decrease in activity, however, the yard still appears to be in operation. A pool of liquid is present at the northwest corner of the yard. The specific source of this liquid could not be identified. Large vehicles (V) and associated ground stains are present in the lot east of SY1. Two locations of probable debris are also observed in this adjacent lot; one area of debris is situated at the head of a west-flowing drainage route.

SY2 has been expanded eastward with the eastern half consisting of junked vehicles and the western half consisting mostly of piled scrap/debris. Parked vehicles are present west of SY2 and appear to be customer or employee parking.

The number of junked vehicles and scrap/debris piles in the main portion of SY3 has increased since 1962. The scrap/debris piles within the fenced area are overgrown with vegetation (VEG) indicating a decrease in activity in this area. Two ground scars (GS) and scattered debris overgrown with vegetation are present east of the current extent of SY3 activity.

A stain originating from the building is noted at the vehicle and equipment storage repair shop. Mounded material and disturbed ground is present south of the building. Pooled liquid is present within the area of disturbed ground and a portion of a mound of material has been extracted. A ground scar is noted where probable debris was observed in 1957.

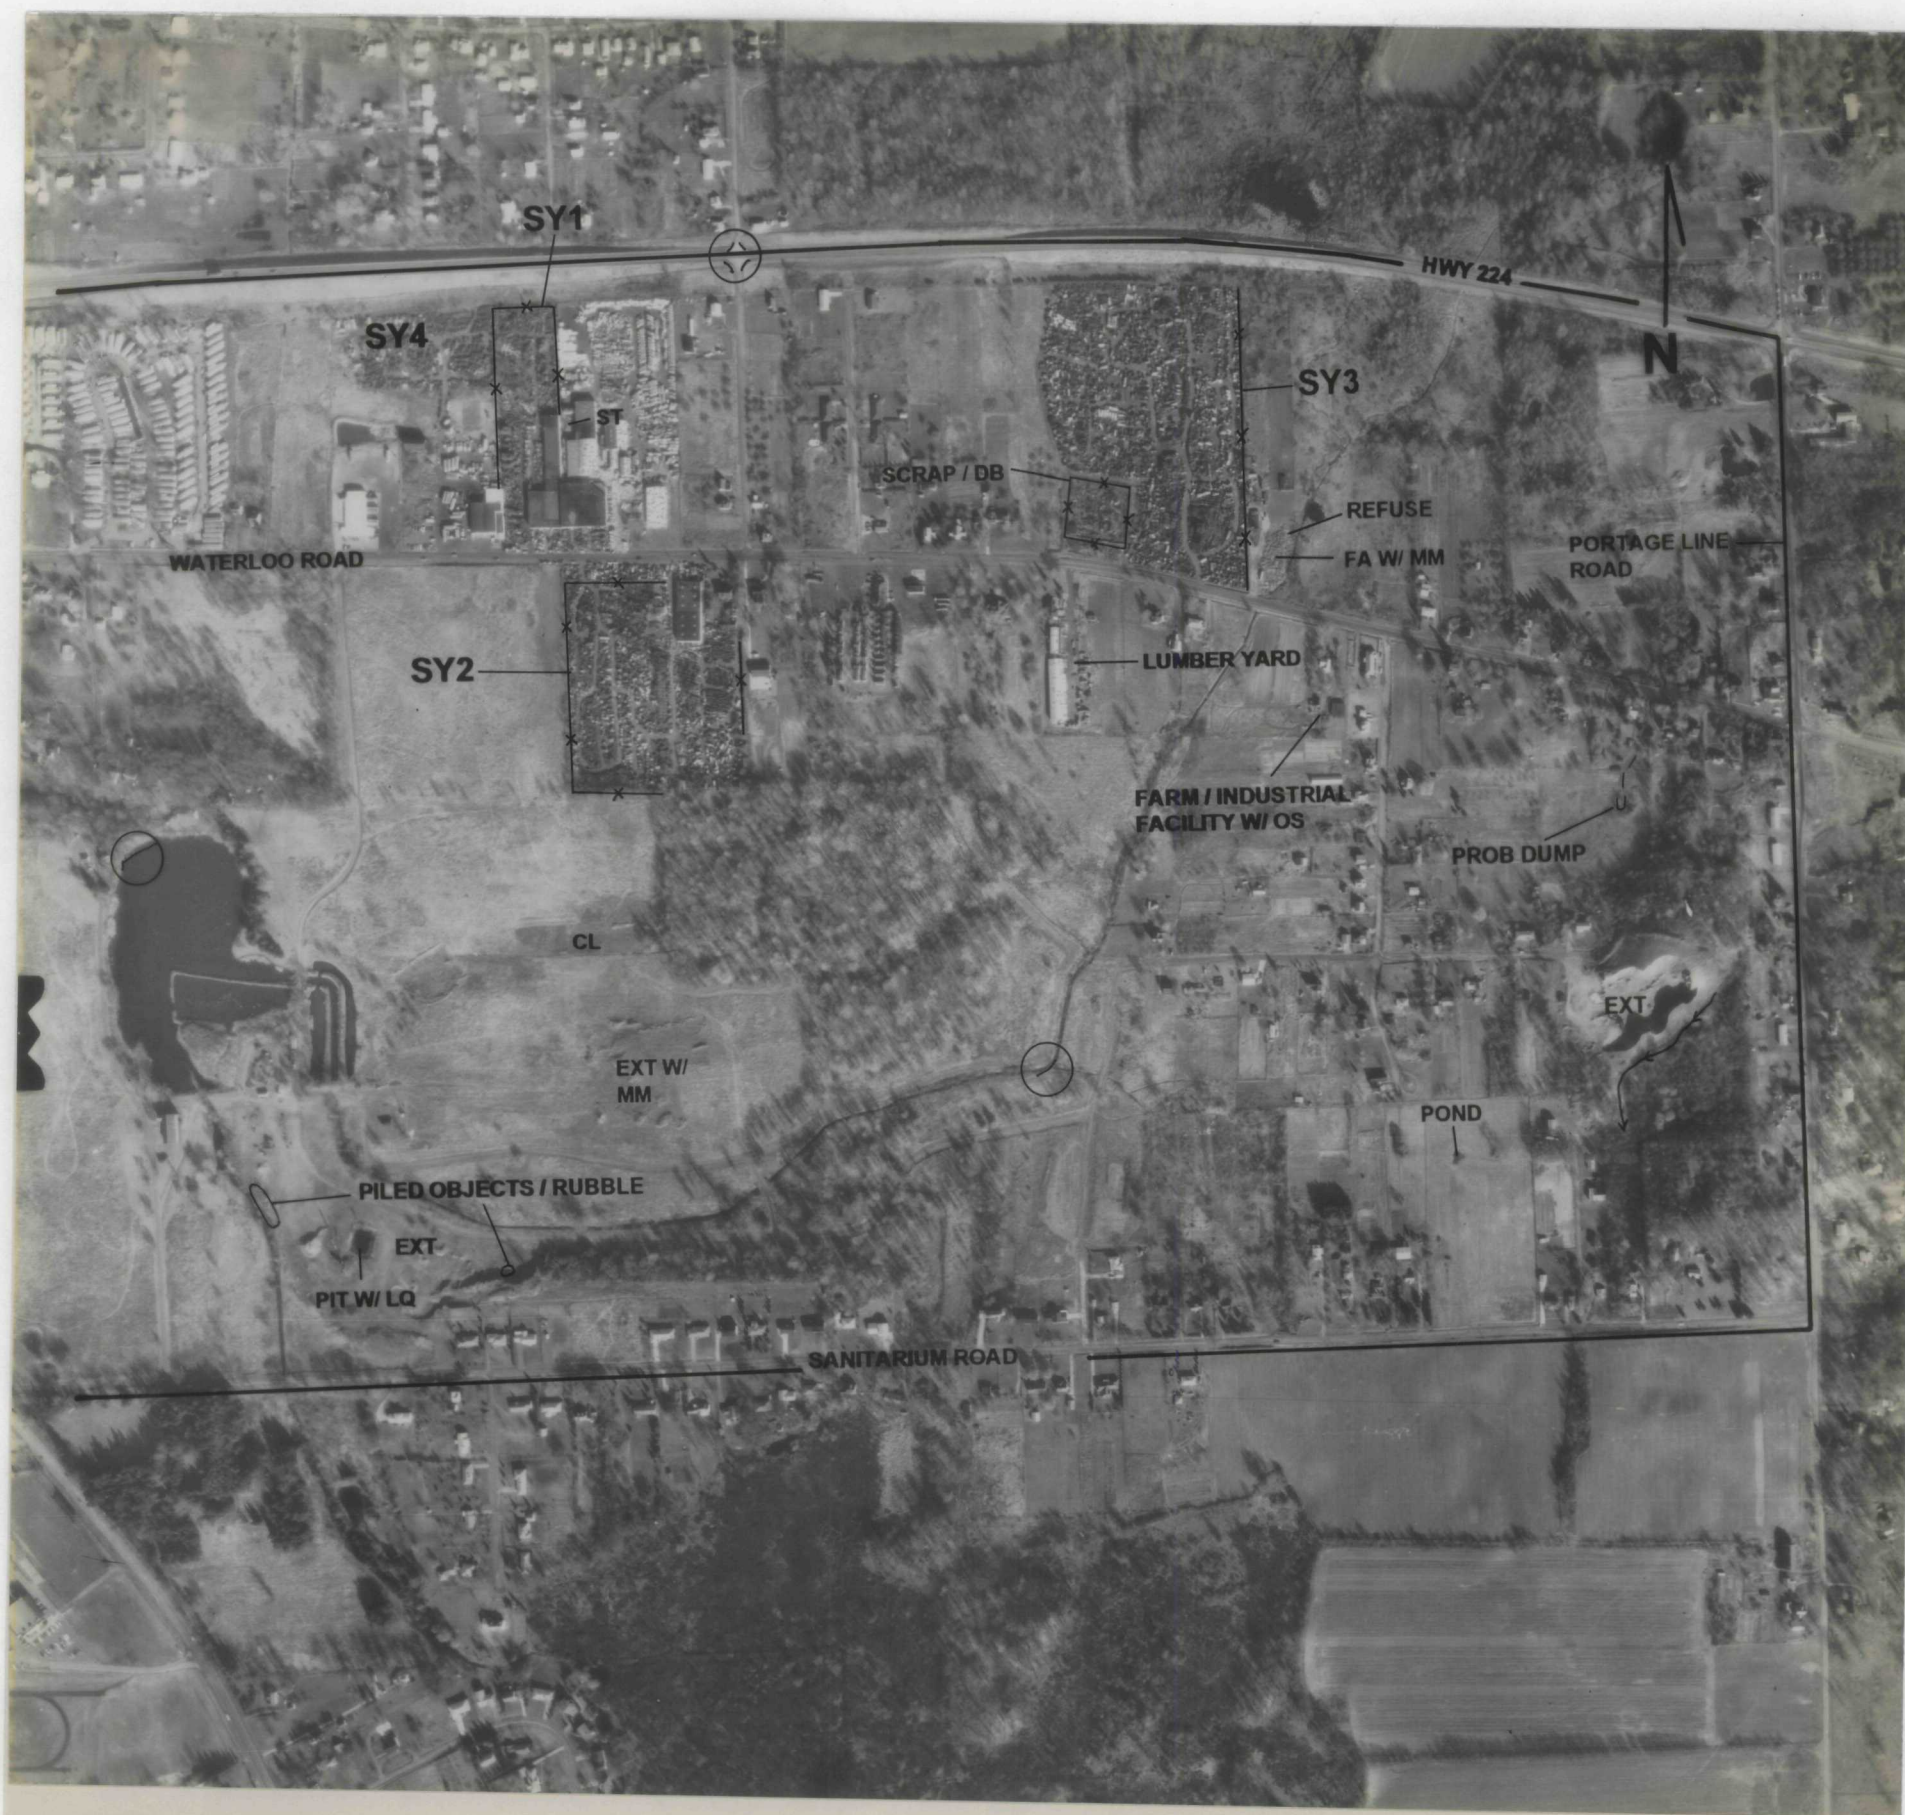
FIGURE 7

All four salvage yards and the extraction areas remain active on this date. A pit with liquid, piles of objects/rubble and mounds of material are observed at the extraction areas in the western portion of the study area. The former vehicle and equipment storage/repair shop has been replaced by a lumber yard. A farm/industrial facility with open storage (OS) of haphazardly placed equipment and objects is present farther east and a probable dump is noted north of the easternmost extraction area.

No significant changes are noted at SY1, SY2, and SY3. However, a fill area (FA) with mounded material and scattered refuse is present east of SY3, where vegetated debris and ground scars were observed in 1966.

SY4 has increased in size and in the number of junked vehicles since 1966. The yard remains unfenced.
